Manhole Inspection Summary

Manhole # **S17G__029MH**

Insp Date: **10/4/07 9:29 AM**

Location Address: **2501 LEXINGTON ST**

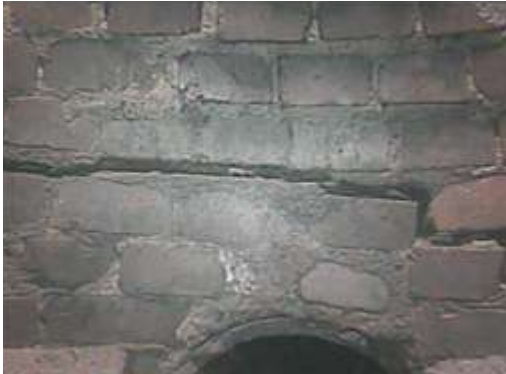
Defect 1

Condition: ☐ Sound ☒ **Cracked** ☐ Root Intrusion ☐ Loose Brick ☐ Deteriorated

CRACK IN BARREL

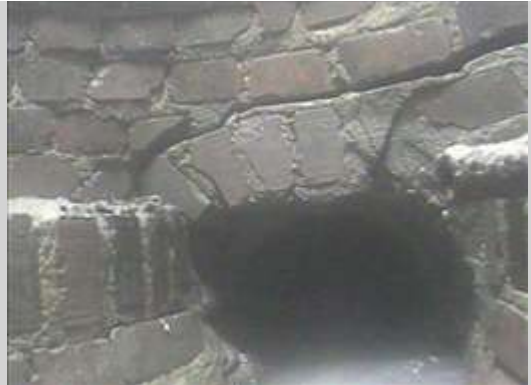
12 O'Clock Outflow

12 in. Circular Gravity Sewer
Pipe Out @ 12 O'Clock

Pipe Height: **6** (in.) Direct
Pipe Material: **Clay** ☐ Pipe Lined
Invert Depth: **7.08** (ft.) Flow Characteristics: **Fast**
Deposits: ☐ None ☐ Mud ☐ Sludge ☒ **Debris** ☐ Grease
Silt Depth: **2** (in.) Deposits Extent: **Medium**
Infiltration: **None** Pipe Seal Cond: **Broken**

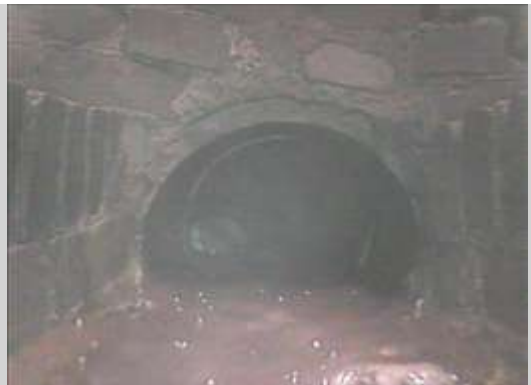
6 O'Clock Inflow

12 in. Circular Gravity Sewer
Pipe In @ 6 O'Clock

Pipe Height: (in.) Direct
Pipe Material: **Clay** ☐ Pipe Lined
Invert Depth: **6.97** (ft.) Flow Characteristics: **Fast**
Deposits: ☒ **None** ☐ Mud ☐ Sludge ☐ Debris ☐ Grease
Silt Depth: (in.) Deposits Extent:
Infiltration: **None** Pipe Seal Cond: **Sound**

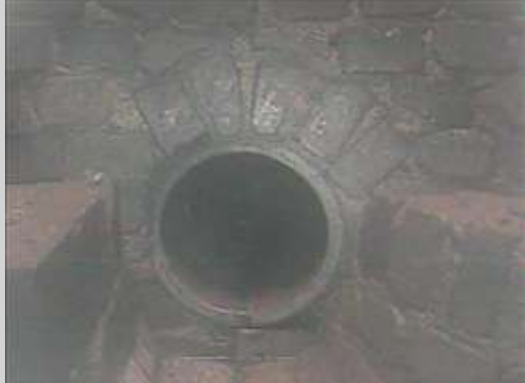
9 O'Clock Inflow

8 in. Circular Gravity Sewer

Pipe In @ 9 O'Clock

Connects To: **Stub connection / abandoned**
